REQUEST FOR TECHNICAL INSPECTION

PROPERTY ADDRESS: §47F Wattle Grove

ISSUE/ITEM TO BE INSPECTED: Inspect rear yard with regards to drainage. New drainage has been installed by plumber but tenant claims the garage still floods

TECHNICAL REPORT

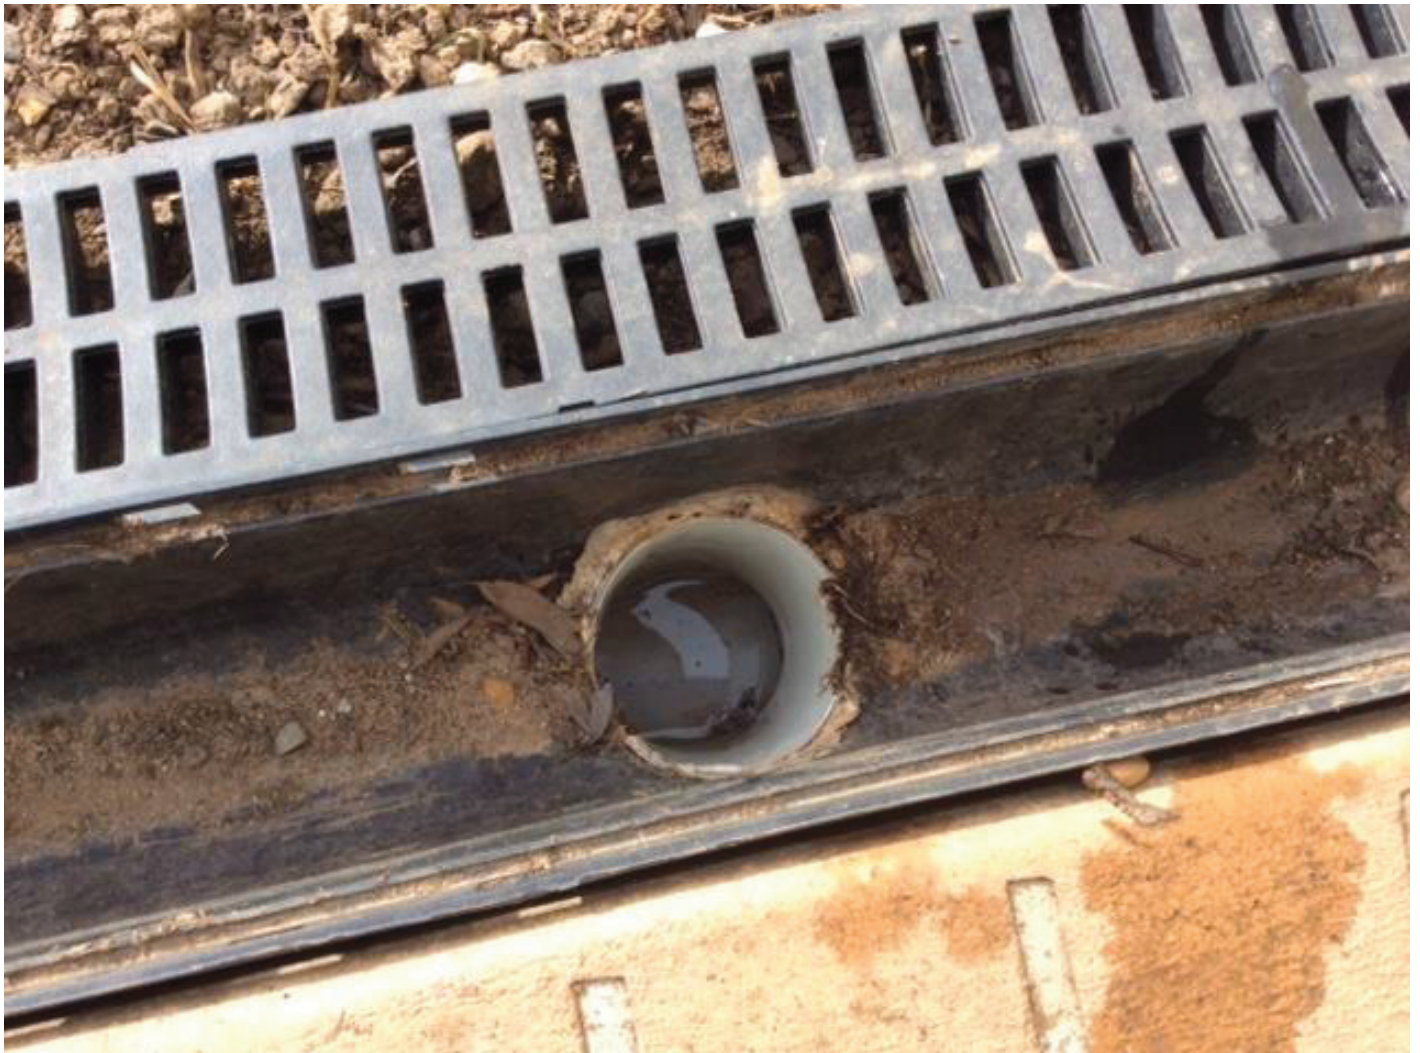
The channel strip drain installed at the rear of the garage.

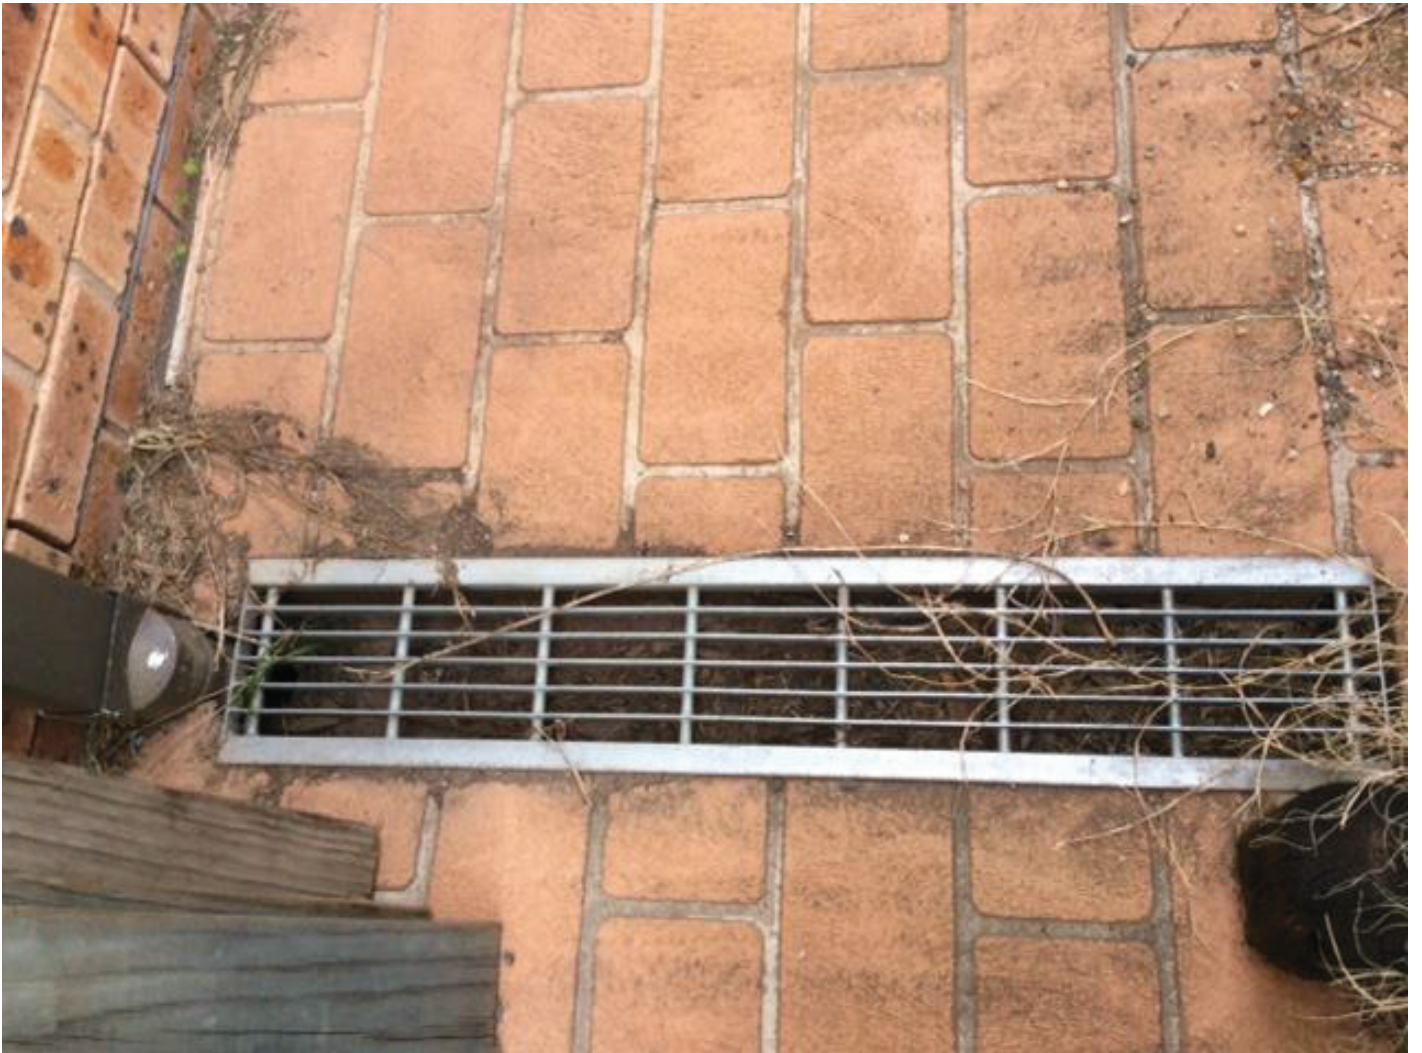
Channel strip drain across path between laundry and rear of house

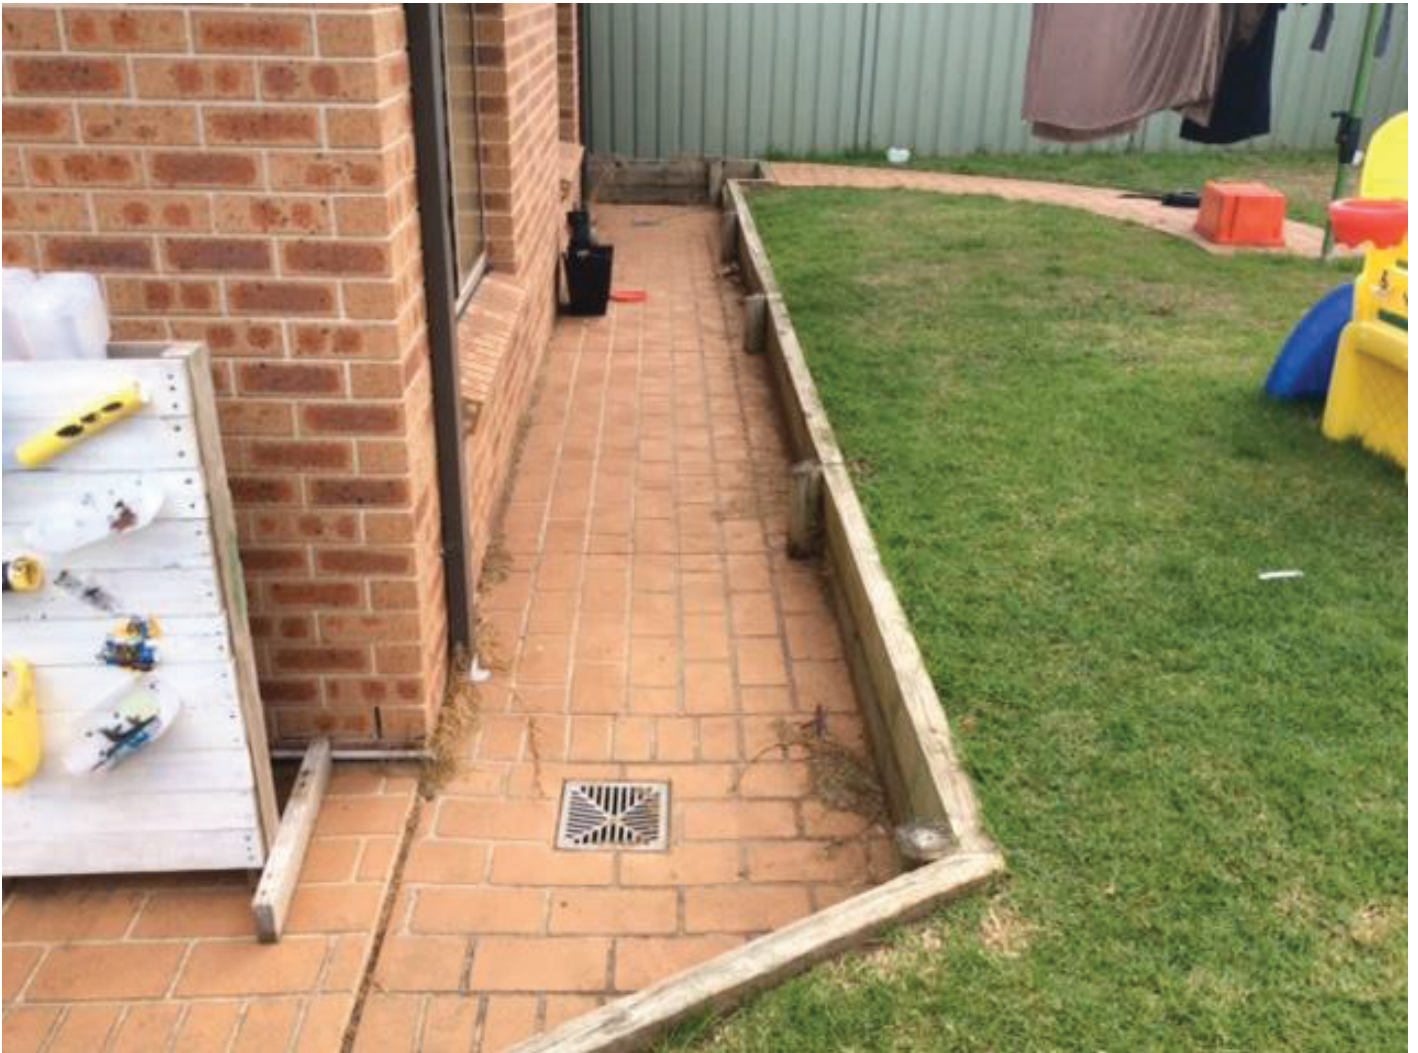
Two 200x200mm stormwater pits located in path at rear of the house below the retaining wall

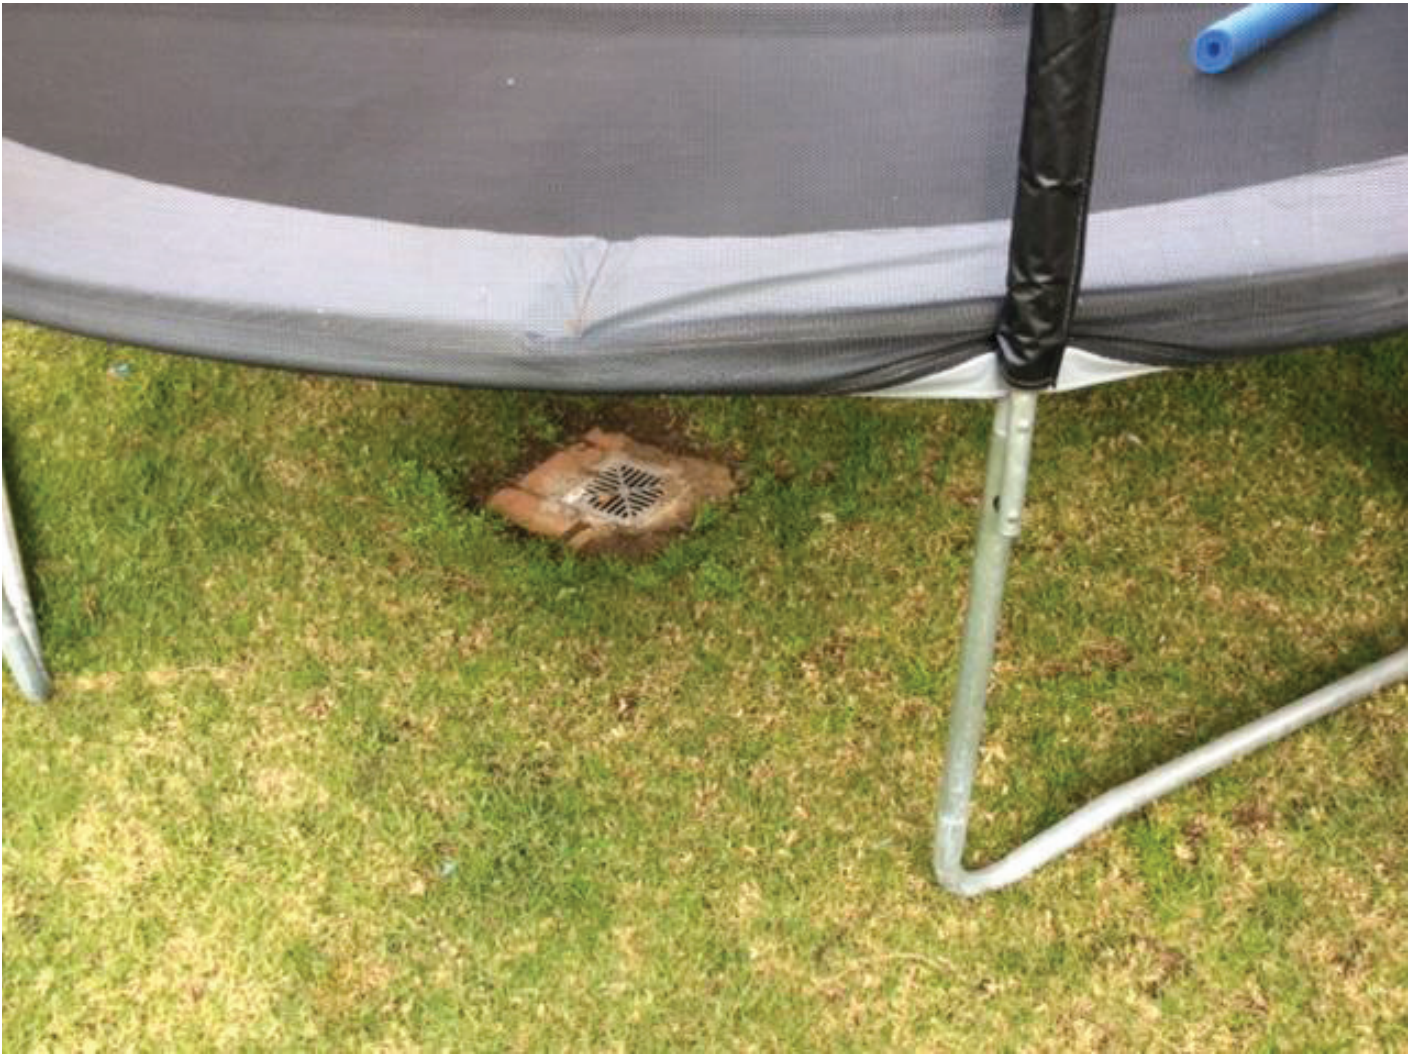
Additional stormwater pit in rear yard between pergola and right side fence

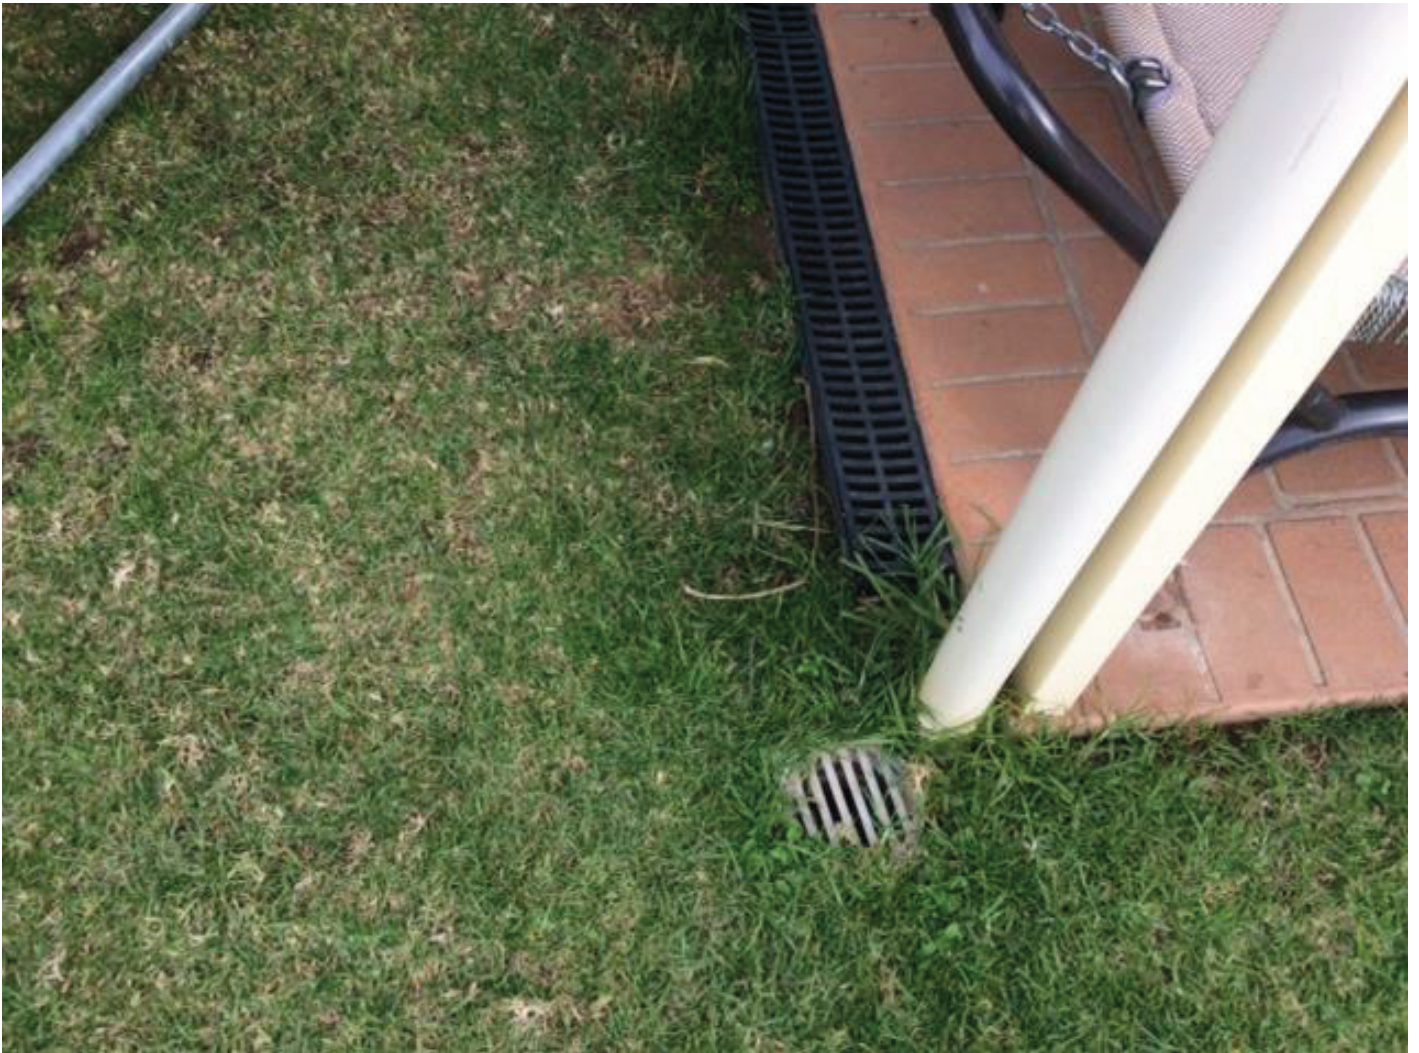
Surface drain and the new channel strip drain installed alongside pergola.

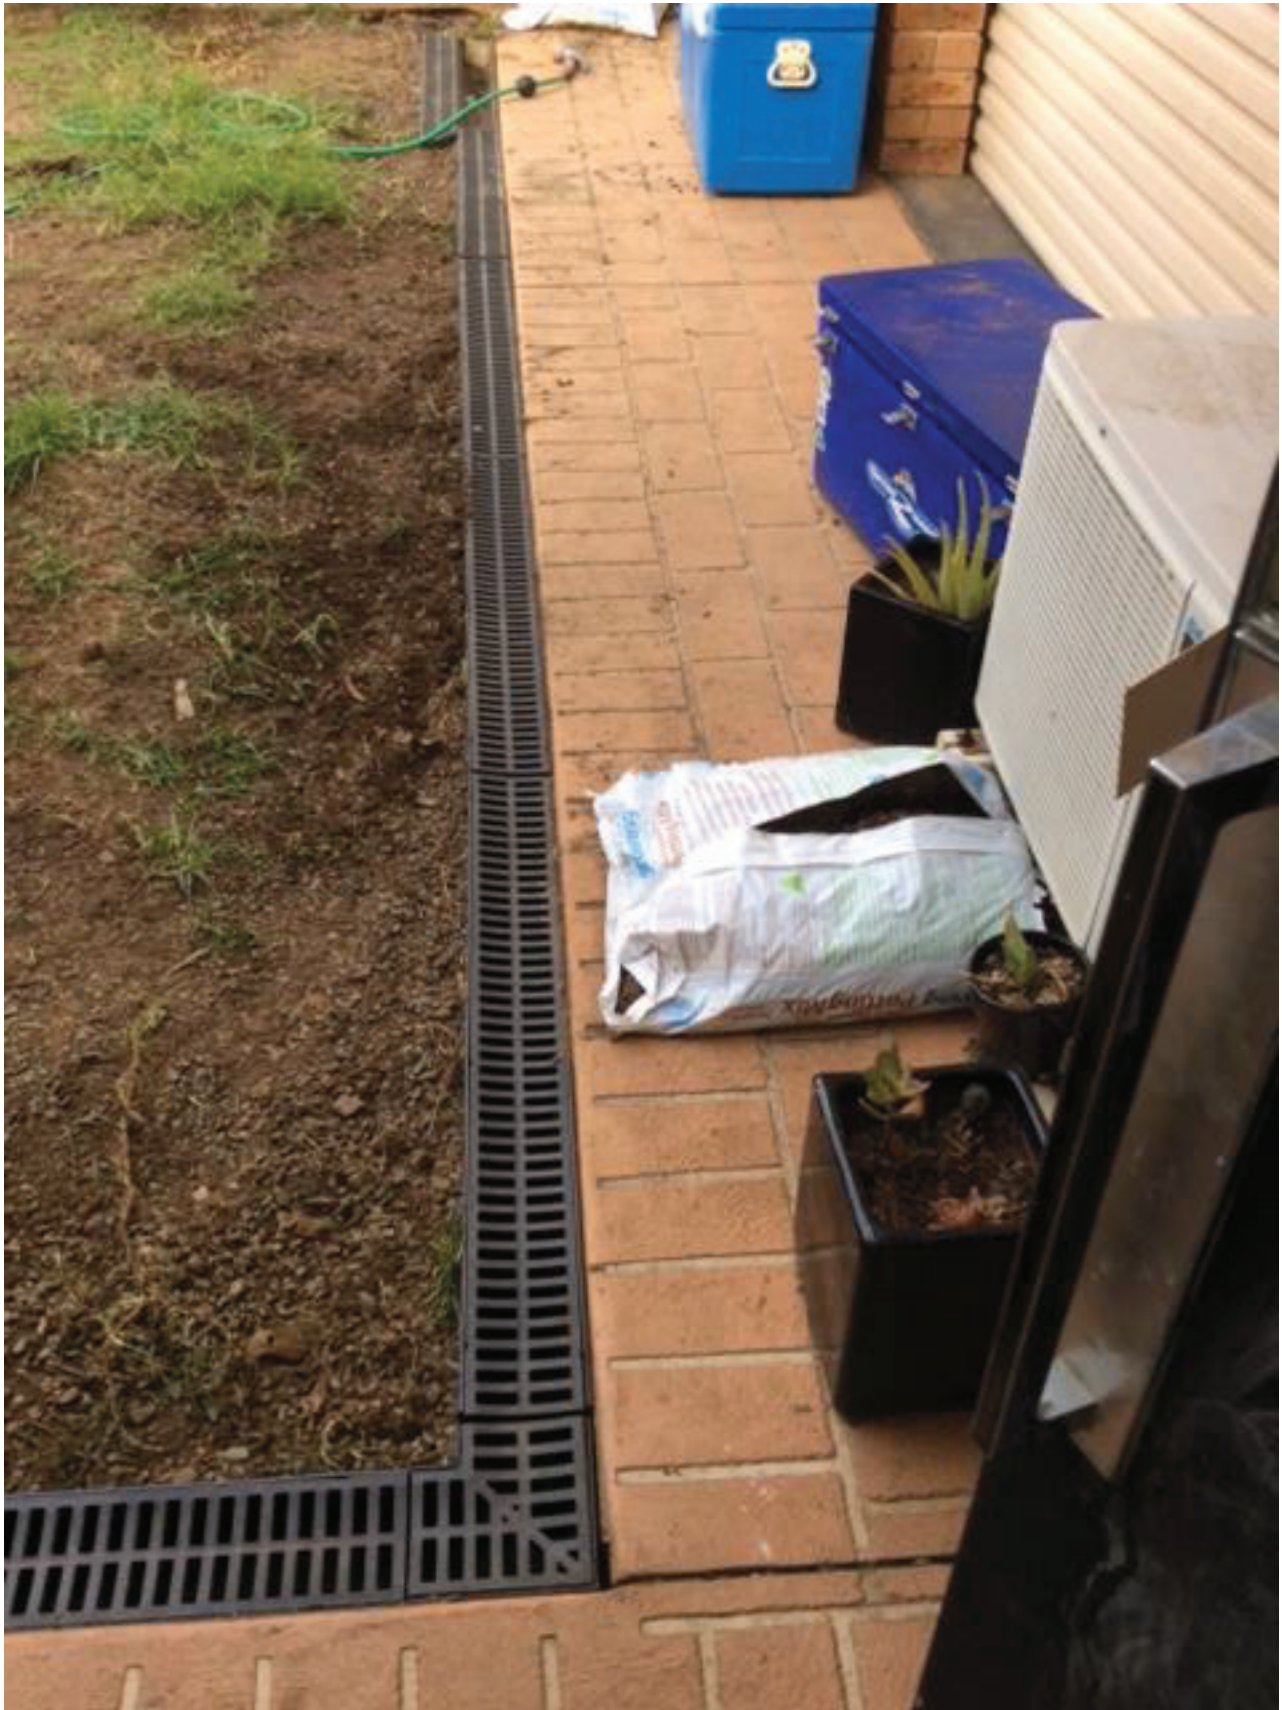
New channel strip drain installed across rear of garage and runs alongside pergola – looking across rear of garage. Note damage by tenants dog

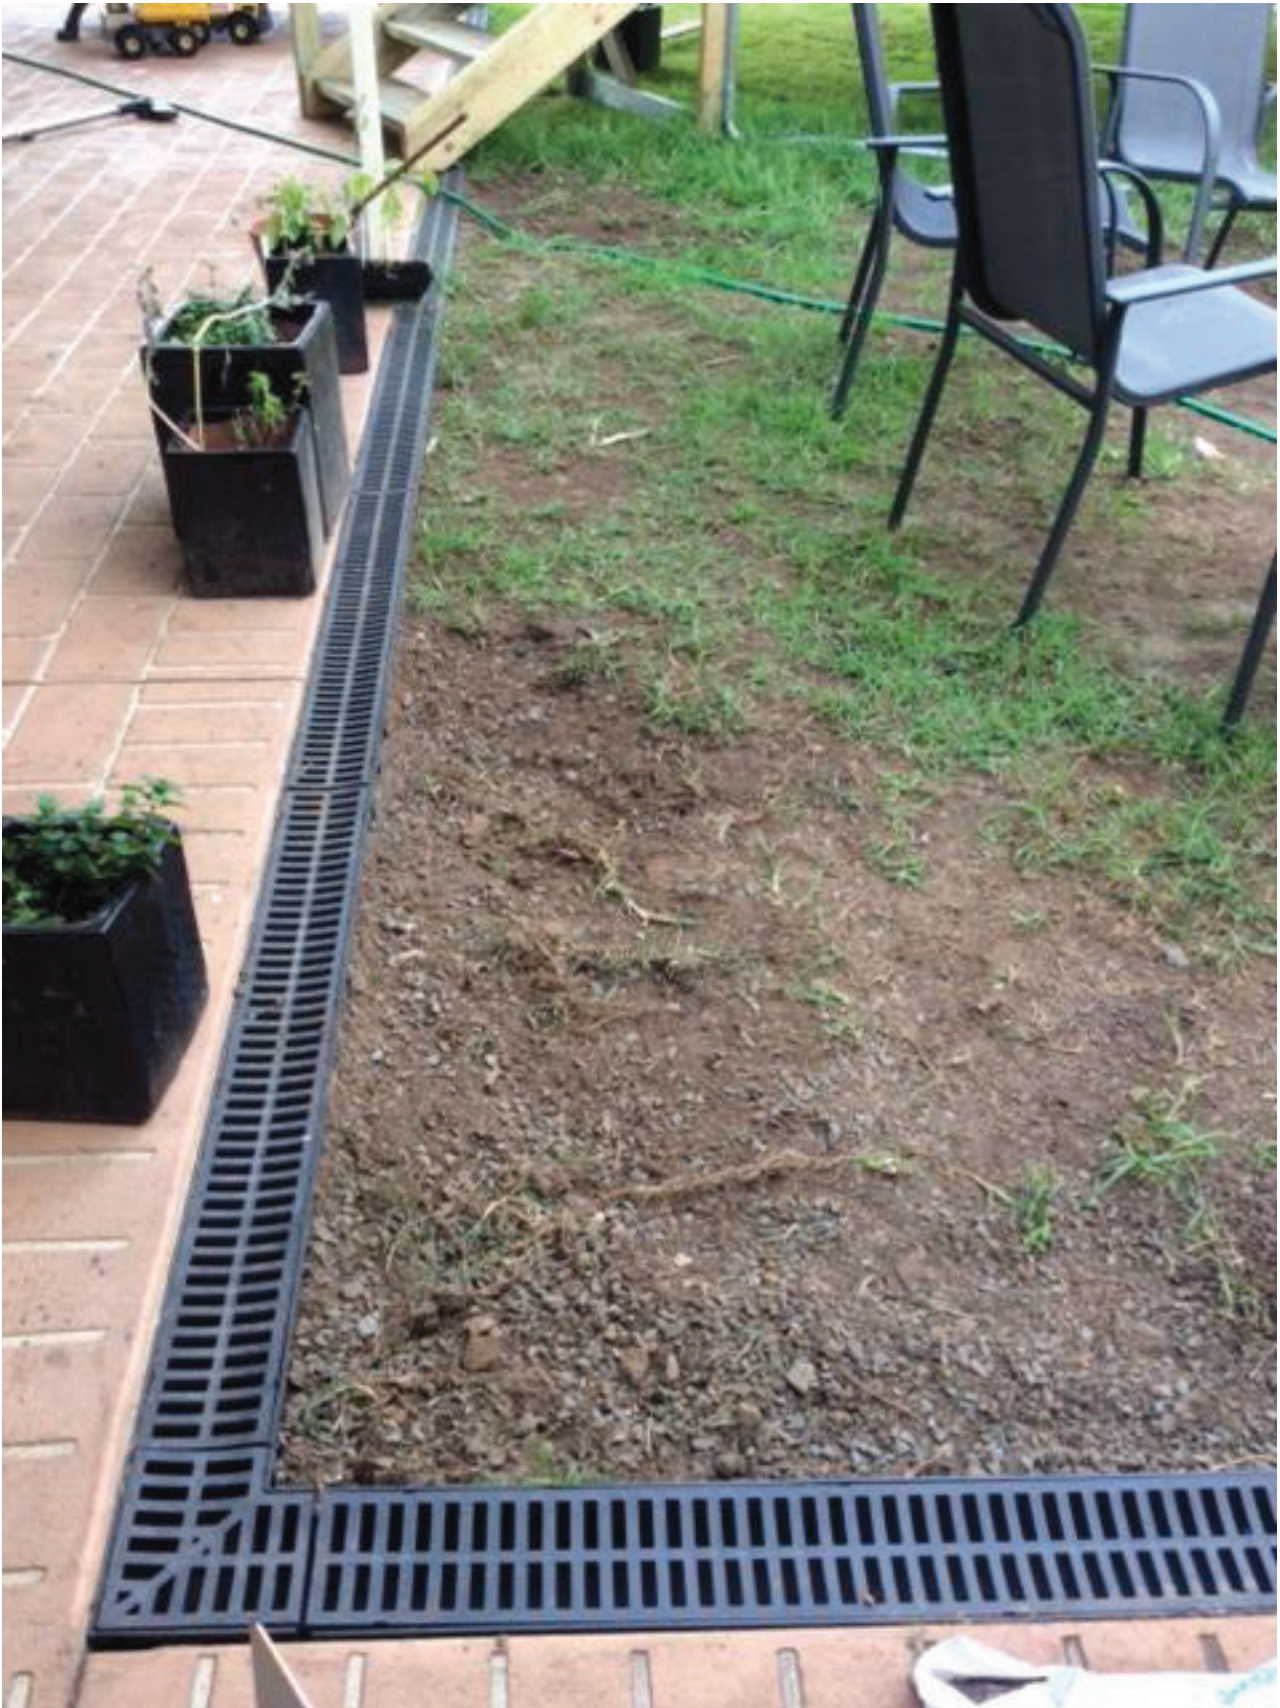
New channel strip drain installed across rear of garage and runs alongside pergola – looking alongside pergola. Note damage by tenants dog

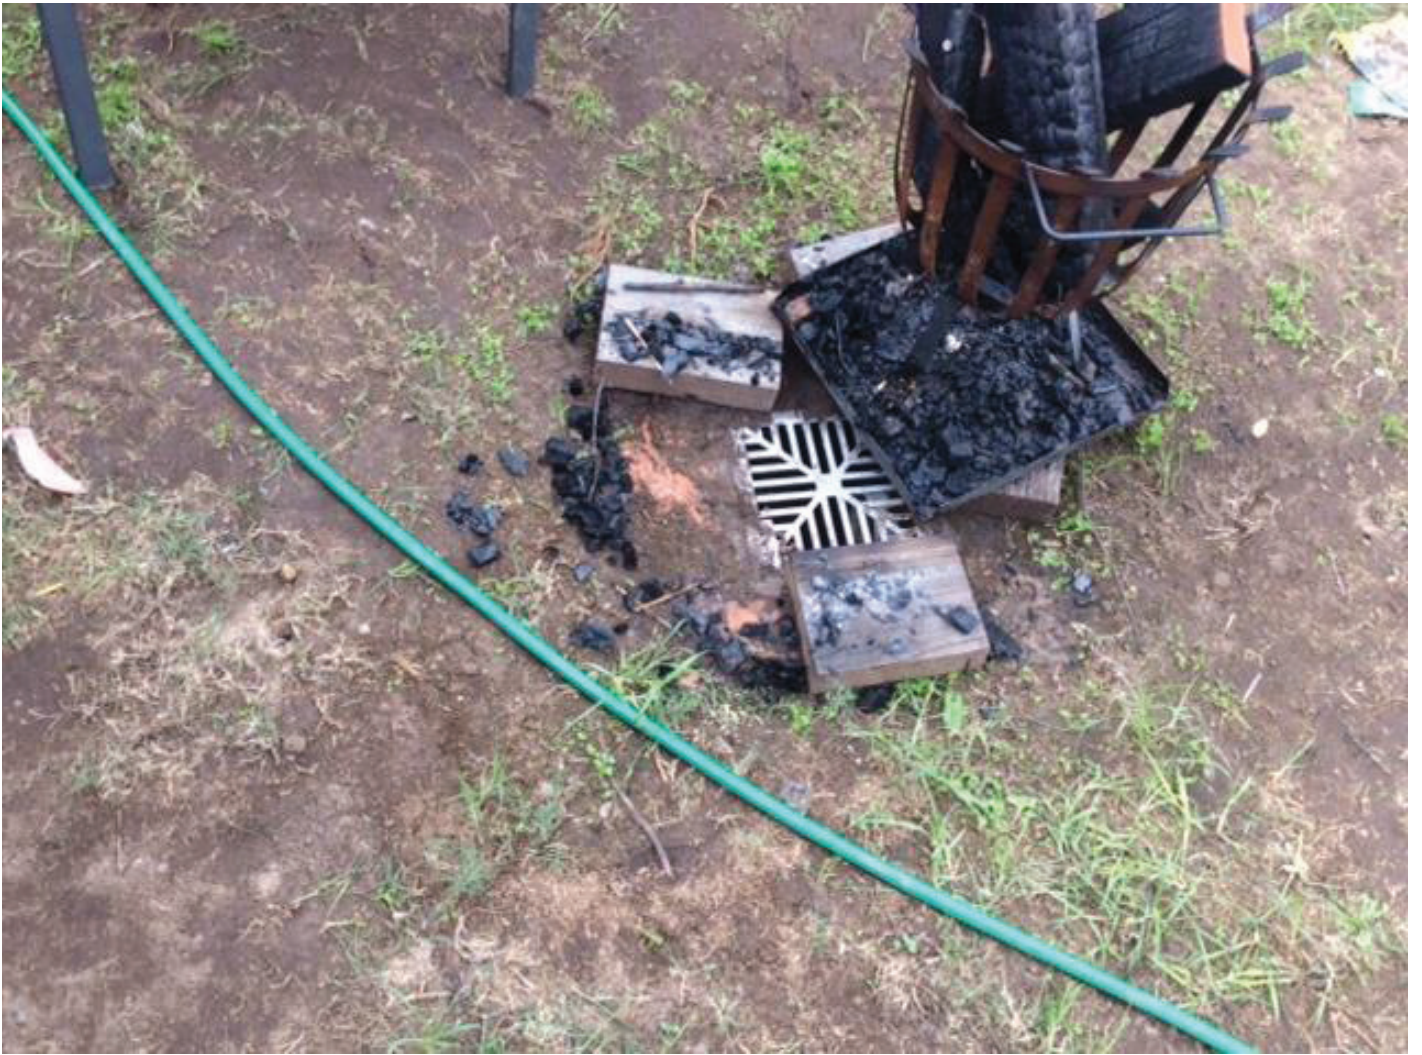
Additional stormwater pit in rear yard between pergola and right side fence

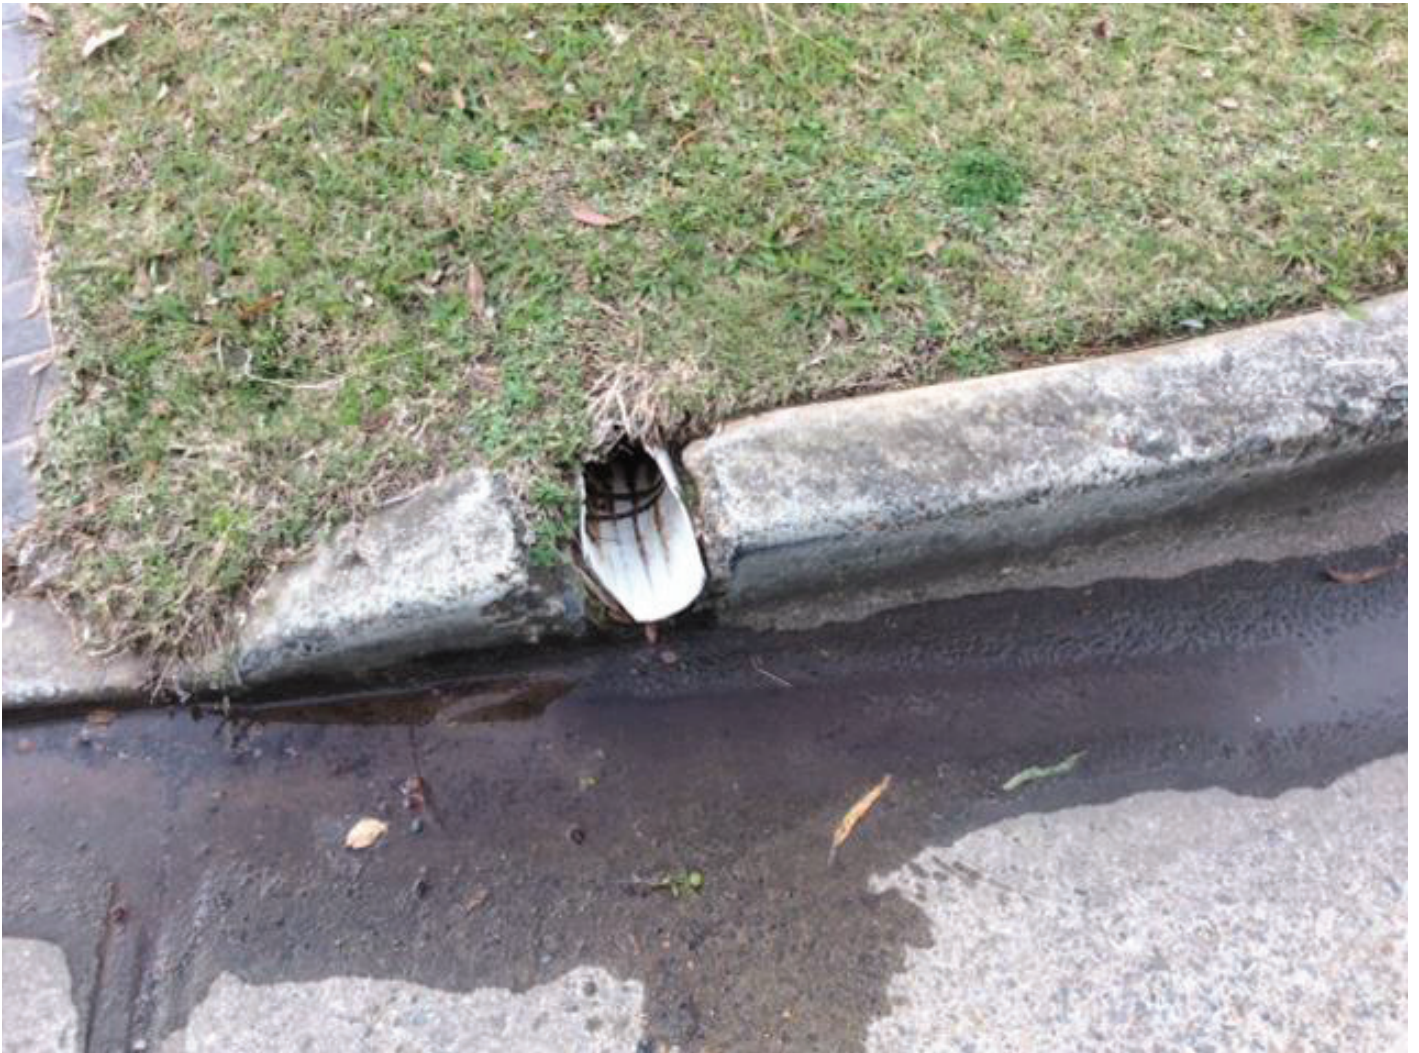
- A further inspection was carried out by myself in July 2106 and the stormwater system was tested again. It was found when filling the stormwater line water line from a hose at the newly installed channel strip drain (2nd last point on the stormwater line) that it took approximately 14 Minutes to fill the complete line and exit at the street.

Water exits the street kerb after 14 minutes of filling the stormwater system.

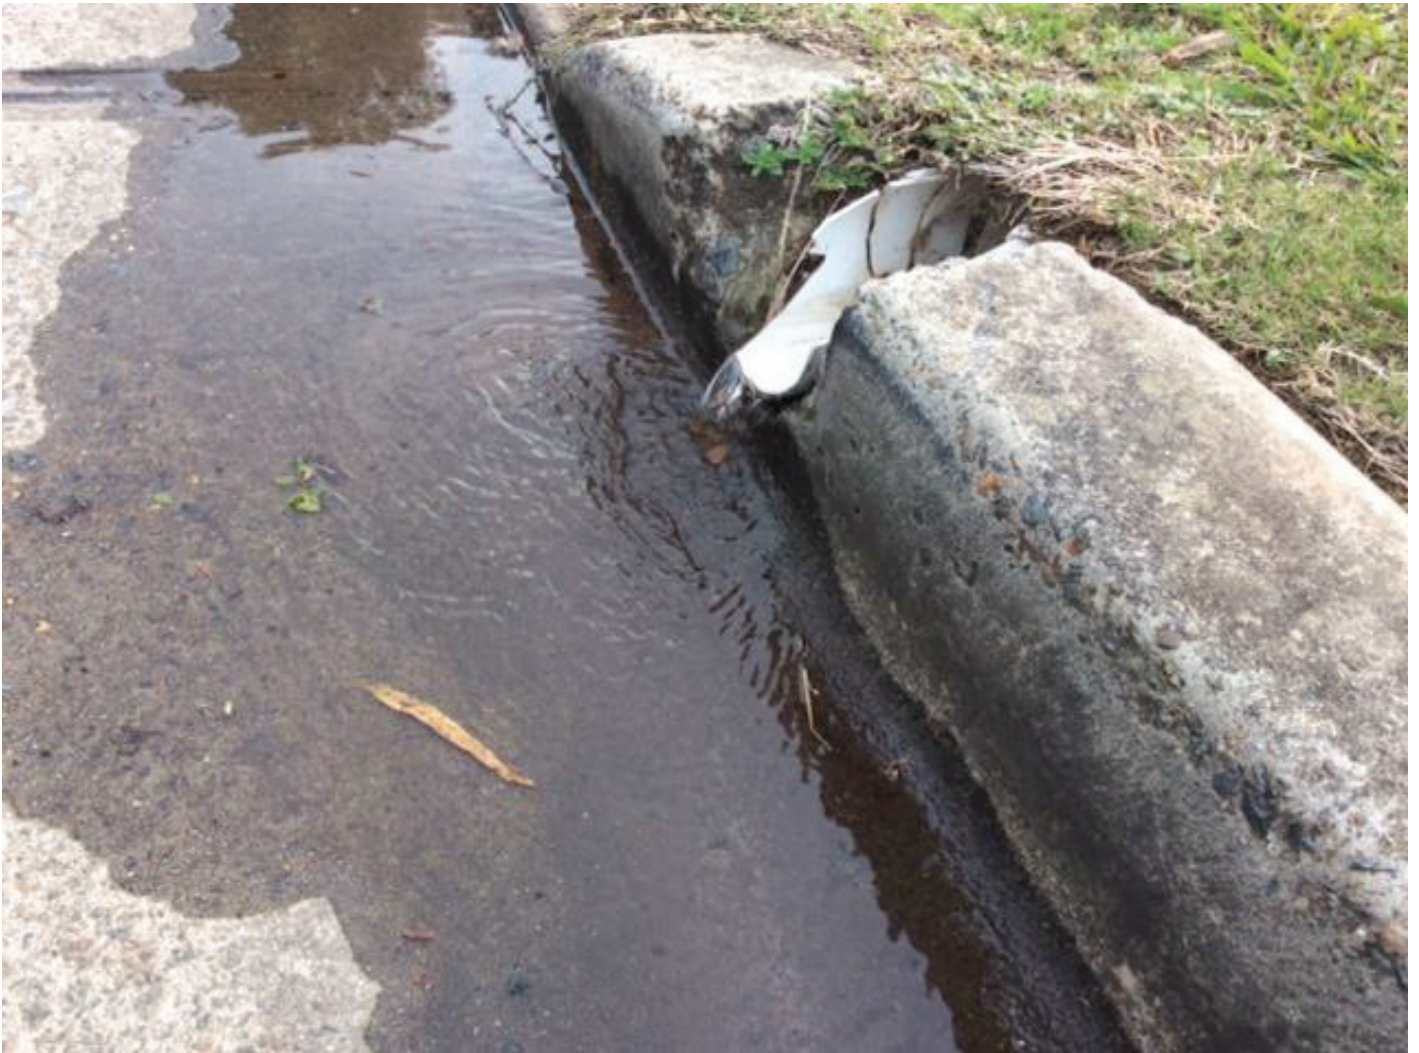
Good water flow at street kerb and equals the hose putting water into the system

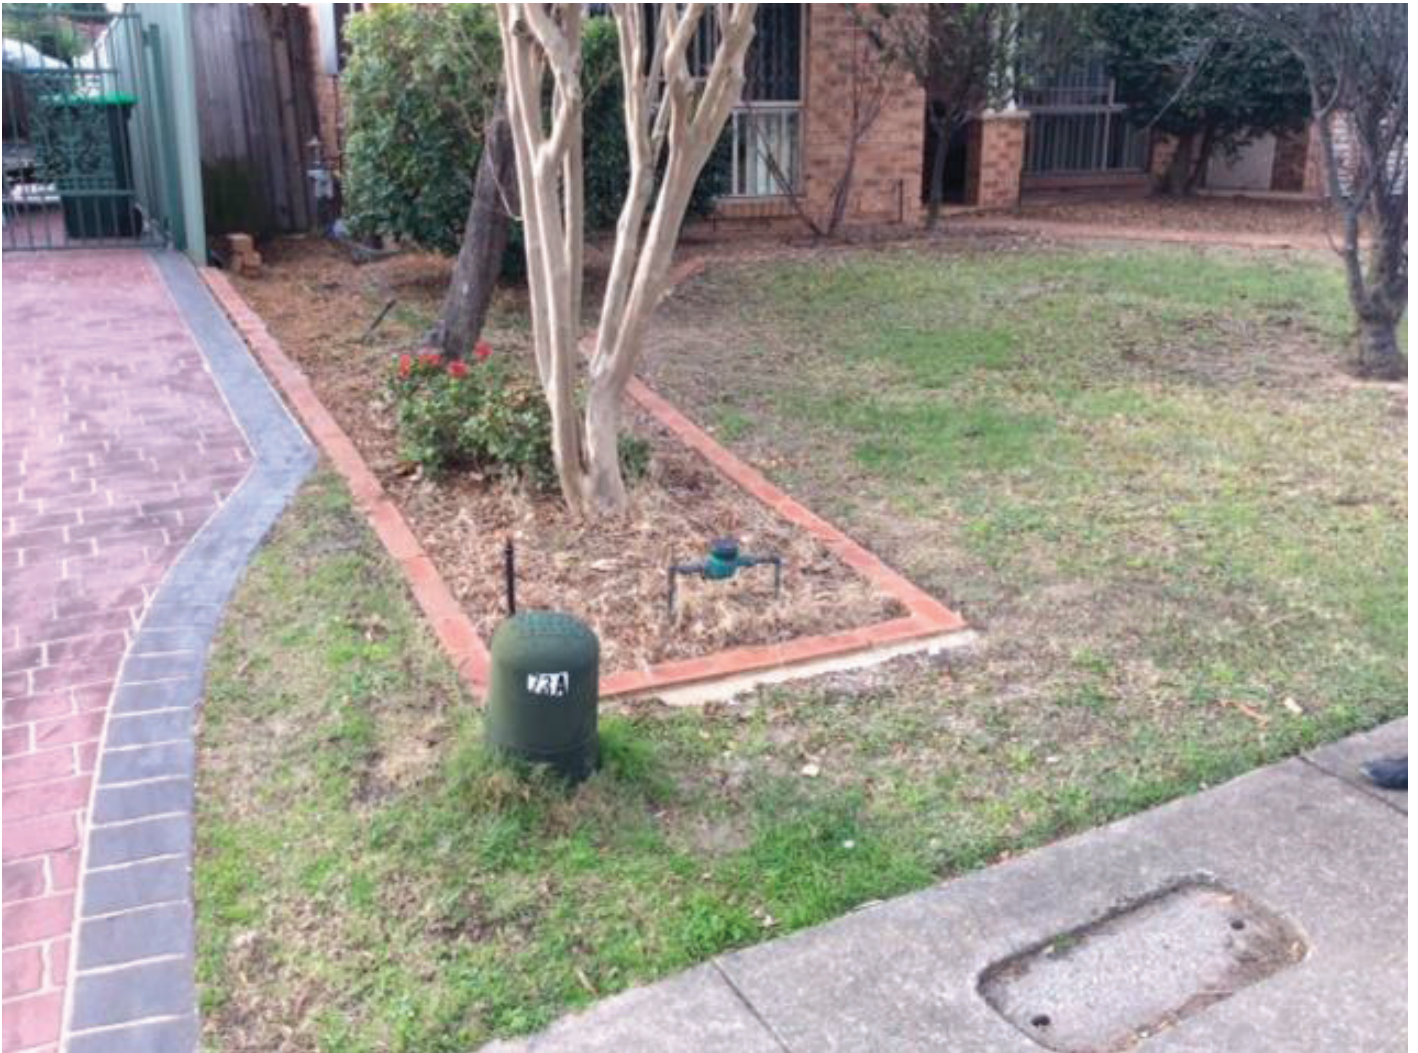
- It was found that there are several services located in the street corridor (including, power, gas, water, Telstra and possibly sewer) and the stormwater would appear to run under these services. This has resulted in a bellying of the stormwater line at this point which allows the collection of some water in the pipe line.

The slight bellying of the pipe line under the services in the street services corridor presents no problems as there is sufficient fall to the street kerb from the last point on the stormwater system, and is no different to a charged system commonly found on properties installed with a water tank. As there is sufficient "head" from the highest point to the lowest point it flushes the system clear when there is high volumes of water in the system.

Services corridor contains, gas, water, phone and power. Stormwater exits at street kerb beyond Telstra pit.
