## **TECHNICAL REPORT**

**DATE OF INSPECTION:** 12/5/2017

**BUILDING TYPE:** Free standing residential dwelling

**BUILDING CONSTRUCTION:** Two Story, Double brick cavity, Concrete first floor slab, Colourbond roof

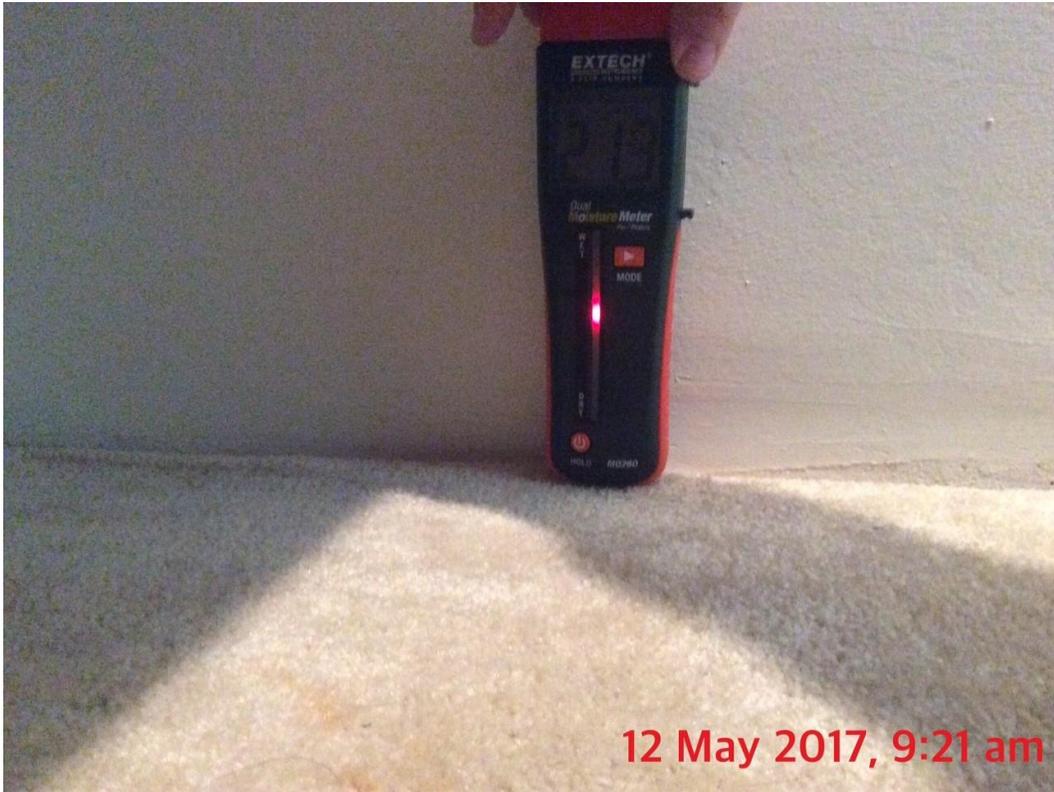
Member reported that they had noticed moisture in the carpet within the linen cupboard. Member advised they decided to dry the carpet to prevent mould approximately 2 weeks before this inspection. Member emptied a bin bag containing towels which were saturated, member stated that the towels were on the floor at the time, and they had kept them as evidence. Member stated that this shower is never used, and the taps only turned on when the cleaner cleans it. The condition of the grout within the shower recess was in very good condition with no discoloration akin to regular use. There was a small crack within the grout between the shower floor and the wall. DHA's plumber has conducted a flood and pressure test to the hot and cold taps and advised that there are no leaks. The plumber had replaced all washers as a precautionary measure. I conducted a moisture reading of the wall from within the linen, which showed a slight reading of 21.3 as shown in picture No.1 below. The moisture meter shows a reading of 15-17 on dry walls as demonstrated to the

member onsite. In my experience, the low reading of the wall does not relate to the condition of the towels. Walls take a significant amount of time to dry, they typically show other signs of moisture by paint bubbling or plaster becoming drummy if there was continued dampness– there were no signs of either.

Picture No.1 showing moisture reading between Bathroom and Linen – 21.3

**RECCMEDATION:** DHA to re grout shower base and first row of wall tiles – a precautionary measure of mega sealing the entire area should also be considered.

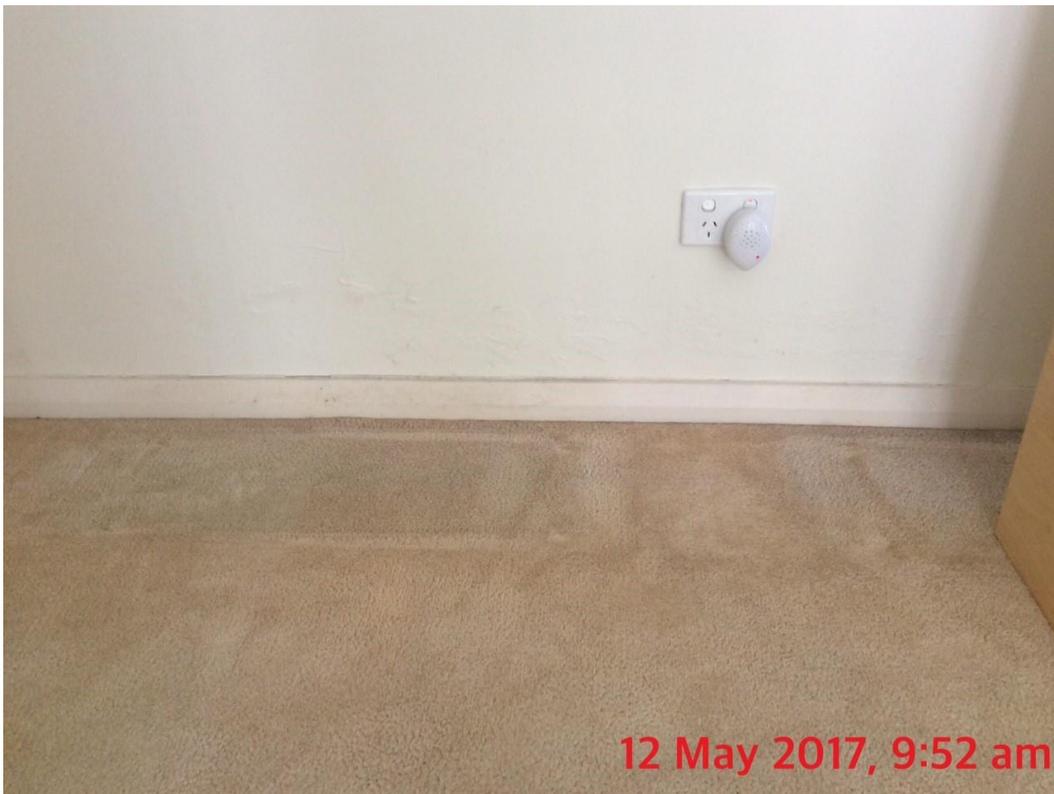
Member reported moisture evident within the wall. It was clear that moisture is evident in the wall as the paint is bubbling at floor level as picture No.2 shows. The condition of the grout within the shower is in poor condition. Heavy discoloration was observed through everyday use. The grout was recessed from the face of the tile, with cracks evident as shown in picture No.3. The silicone between the shower hob, wall and shower screen was in poor condition. DHA had previously re-grouted the shower recess on 7/10/2014 following reports of the leaking shower – the condition of the grout could be attributed to either, poor workmanship when re-grouted, natural movement, excessive chemicals and scrubbing when cleaning.

Picture No.2 – Showing paint bubbling above skirting from Ensuite shower

**RECCOMENDATION:** DHA to re-grout entire recess, re silicone all previously silicone areas, and apply a mega seal to entire shower recess. Wall to be allowed to dry, and repainted at change of tenancy.

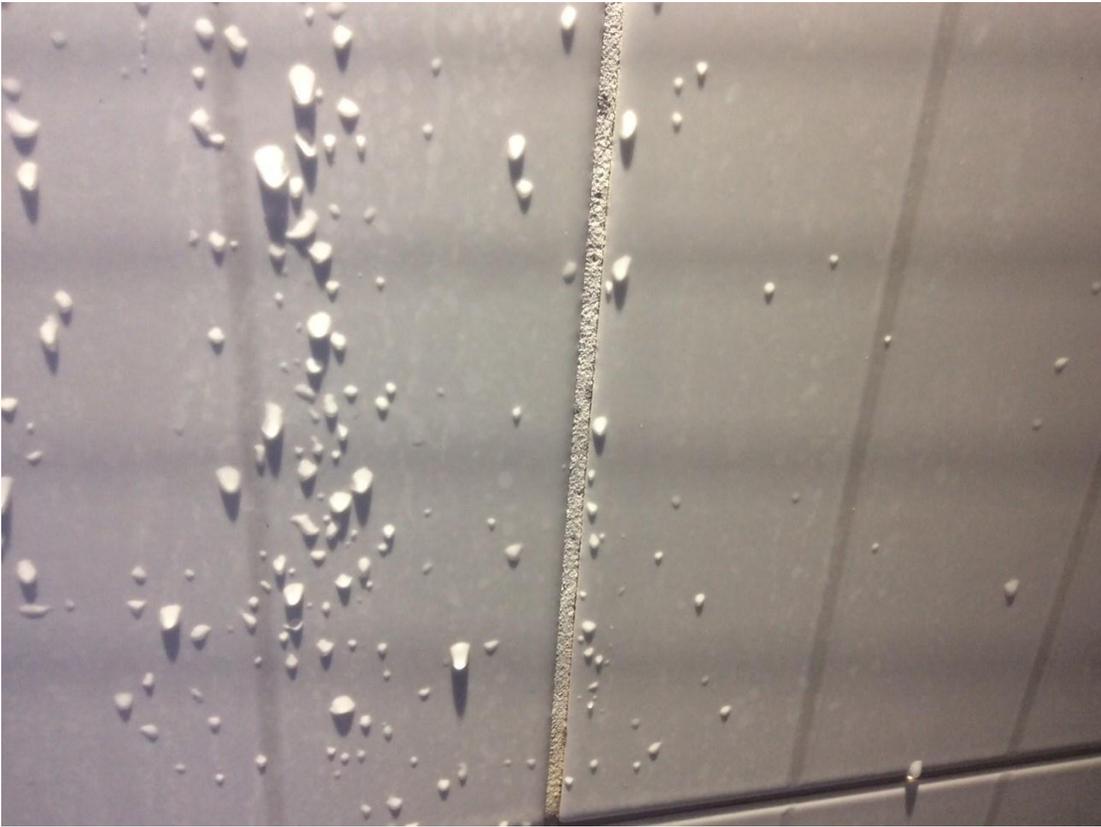
Picture No.3 – Poor condition of grout, cracked on left hand edge of right tile

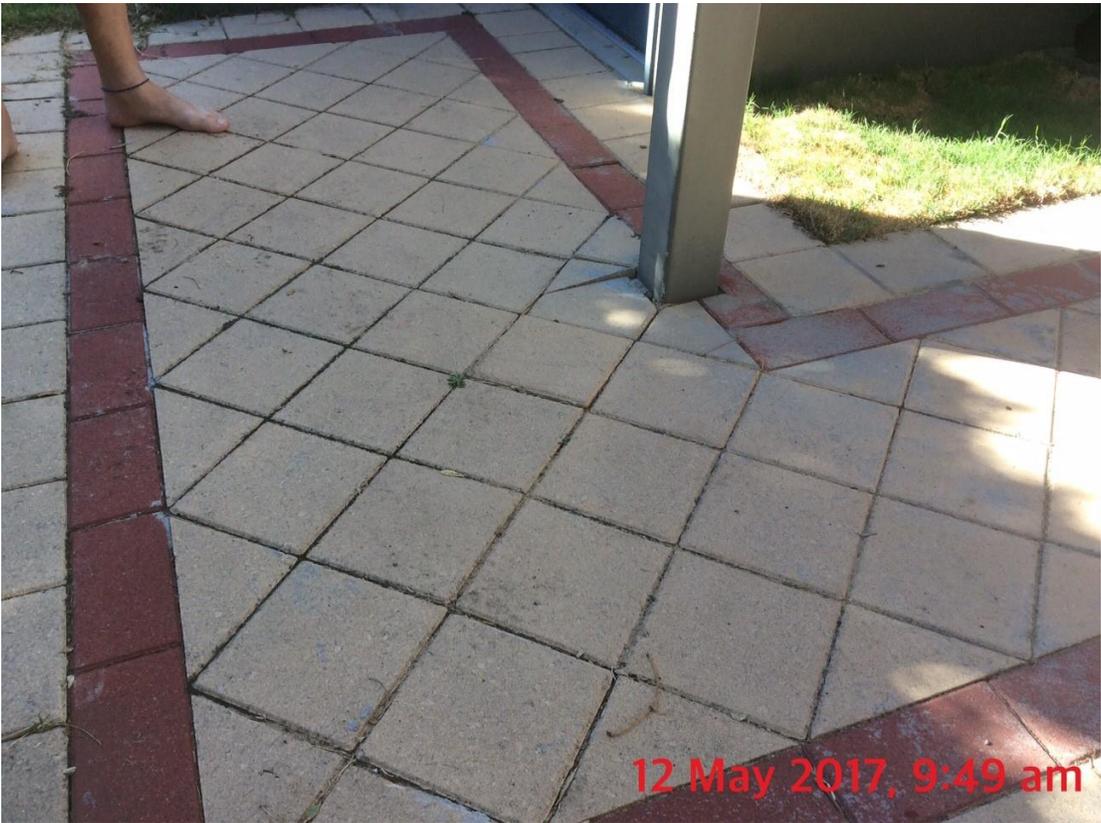
Member reported this issue as a safety concern. It was evident that a tree root from a nearby tree was lifting the pavers shown in picture No.4 & 5. Whilst evident, it is my belief that the lifting is slight and not a safety concern. There is one paver next to the steel post which is protruding the finished height by approximately 10mm. Member wanted it noted this is a trip hazard. I agreed that, although unlikely, it could be possible to trip and raised a MITM for a contractor to attend. I called the contractor to ensure the member was contacted the same day to make a booking.

Picture No.4 – Showing area of paving affected by tree root

**RECCOMENDATION:** MITM raised from site, no further action required.

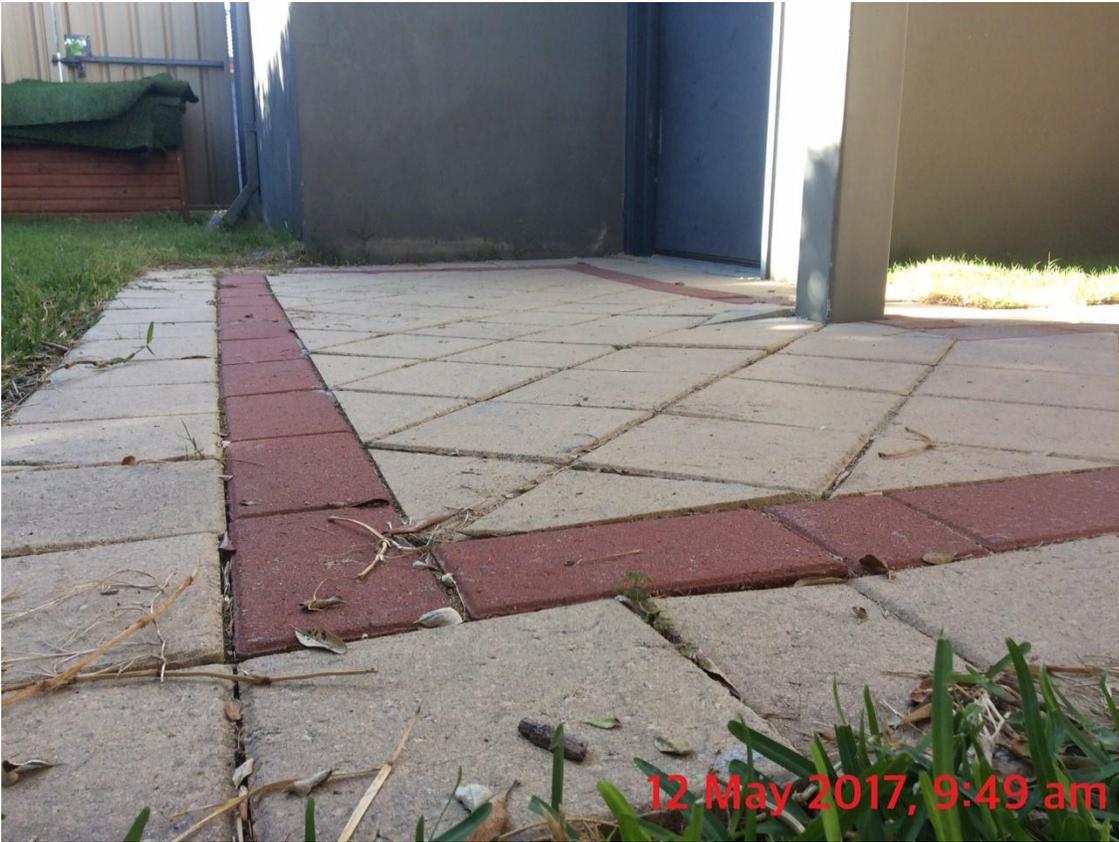
Picture No.5 showing area affected by tree root, and x1 paver protruding by 5-10mm next to steel post

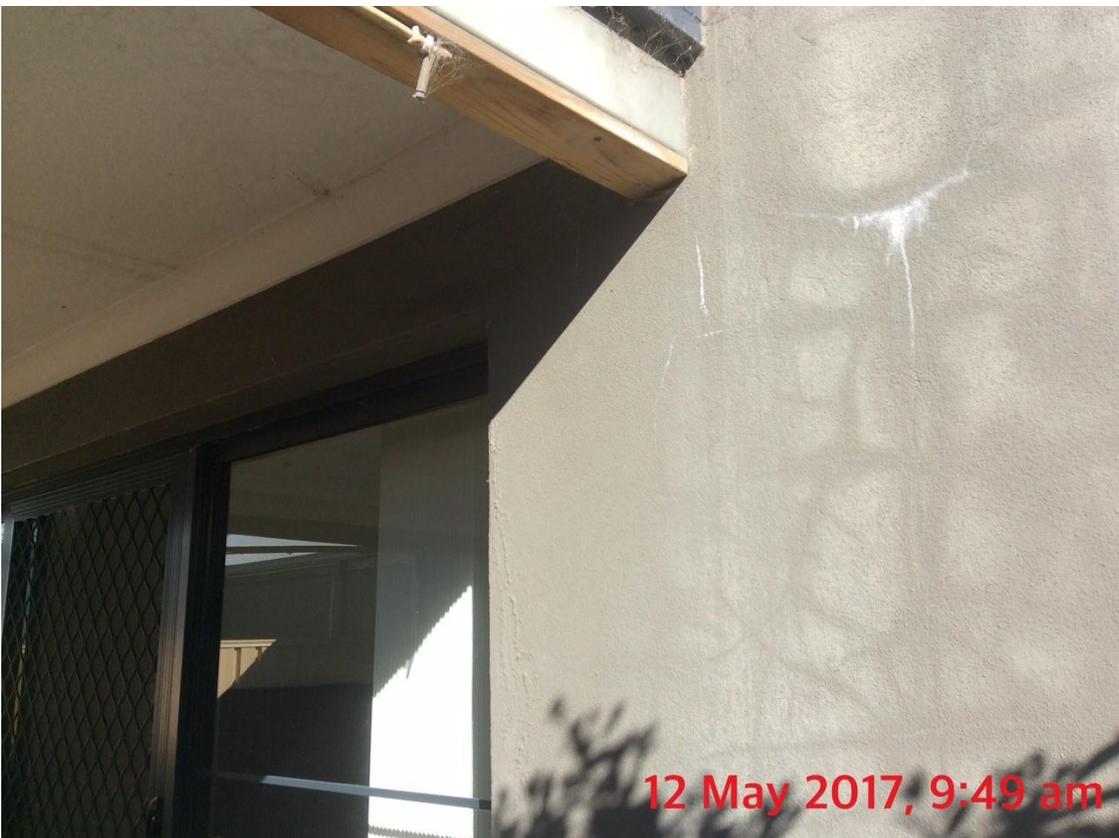
Entire external wall of this property is rendered and map cracking is evident throughout. Paint is also fading on the western elevation. Map cracking is common due to expansion and contraction of materials. There is no evidence of the render becoming drummy and coming off of the walls. The map cracking on this property was in line with community standards as all the properties on the street were showing the same signs of aging.

I observed that the external paint was bubbling underneath the front balcony, and either side of the alfresco area. The paint underneath the front balcony can be attributed to rain coming from the balcony and running down the wall during wet weather. The paint bubbling to the rear of the property can be attributed to a retic/misting set up installed to the eaves on the perimeter of the alfresco, this can be seen in picture No.6

Picture No.6 – Showing map cracking, paint bubbling, and sprinkler/misting system

**RECCOMENDATION:** Tenant to remove sprinkler/misting setup, DHA to conduct external paint at next vacancy.

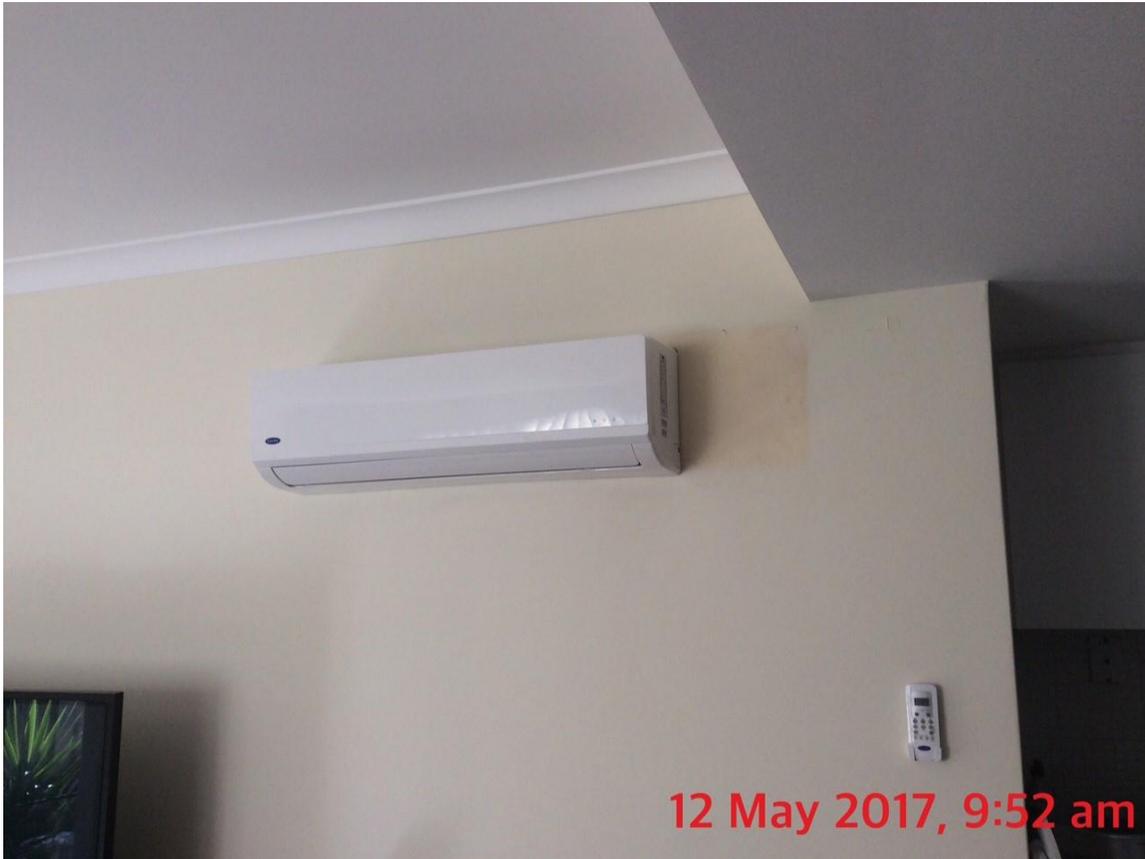
Member voiced displeasure at seeing old paint work now a new unit had been installed, this is shown in picture No.7. I do not believe this to be of any concern or cause for immediate maintenance. Property recently had all A/C units upgraded in line with defense requirements.

Picture No.7 showing area of old paint visible now new A/C system has been installed.

**RECCOMENDATION:** DHA to conduct routine maintenance at next vacancy
