**PRELIMINARY SITE
INVESTIGATION (PFAS)
Lot 4873 and Lot 9370
Lee Point, NT**

Prepared for: Defence Housing Australia
Date: 30 July 2021
Reference No: JC0808
Report Version: JC0808_PSI/01

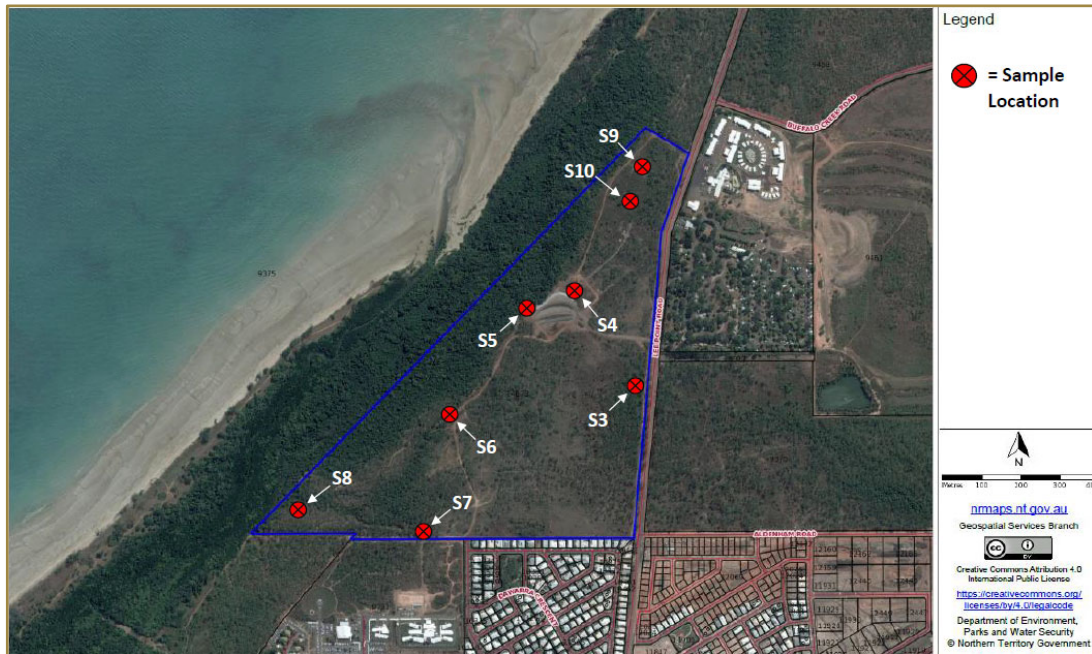
Figure 4: Sample Location Plan, Lot 4873

Sample No.	Location Description	Rationale
1	Lot 9370, centre, adjacent burnt-out car / imported soil	Potential point PFAS contamination source associated with AFFF fire suppression response.
2	Lot 9370, natural drainage line where surface water flows offsite	Potential diffuse contamination pathway from an unknown source.
3	Lot 4873, east boundary, drainage line	Potential diffuse contamination pathway from an unknown source.
4	Lot 4873, within location of former communications facility compound, adjacent to imported fill stockpiles	Communications facility compound and newly imported fill stockpiles considered an area of interest.
5	Lot 4873, within an erosion gully west of and immediately adjacent to the location of former communications facility compound	Potential diffuse contamination pathway from an unknown source within the former communications facility compound.
6	Lot 4873, west portion, erosion gully	Potential diffuse contamination pathway from an unknown source.

7	Lot 4873, south boundary, erosion gully	Potential diffuse contamination pathway from an unknown source.
8	Lot 4873, south-west boundary, erosion gully	Potential diffuse contamination pathway from an unknown source.
9	Lot 4873, north portion, adjacent concrete hardstands / bunker of the old Missile Launching facility	Redundant concrete foundations considered an area of interest.

Sample No.	Location Description	Rationale
10	Lot 4873, north portion, adjacent concrete hardstands / bunker of the old Missile Launching facility	Redundant concrete foundations considered an area of interest.
